Request to surplus Alma property 8.2022

426 West 12th Street, Alma, Georgia

The Inspection

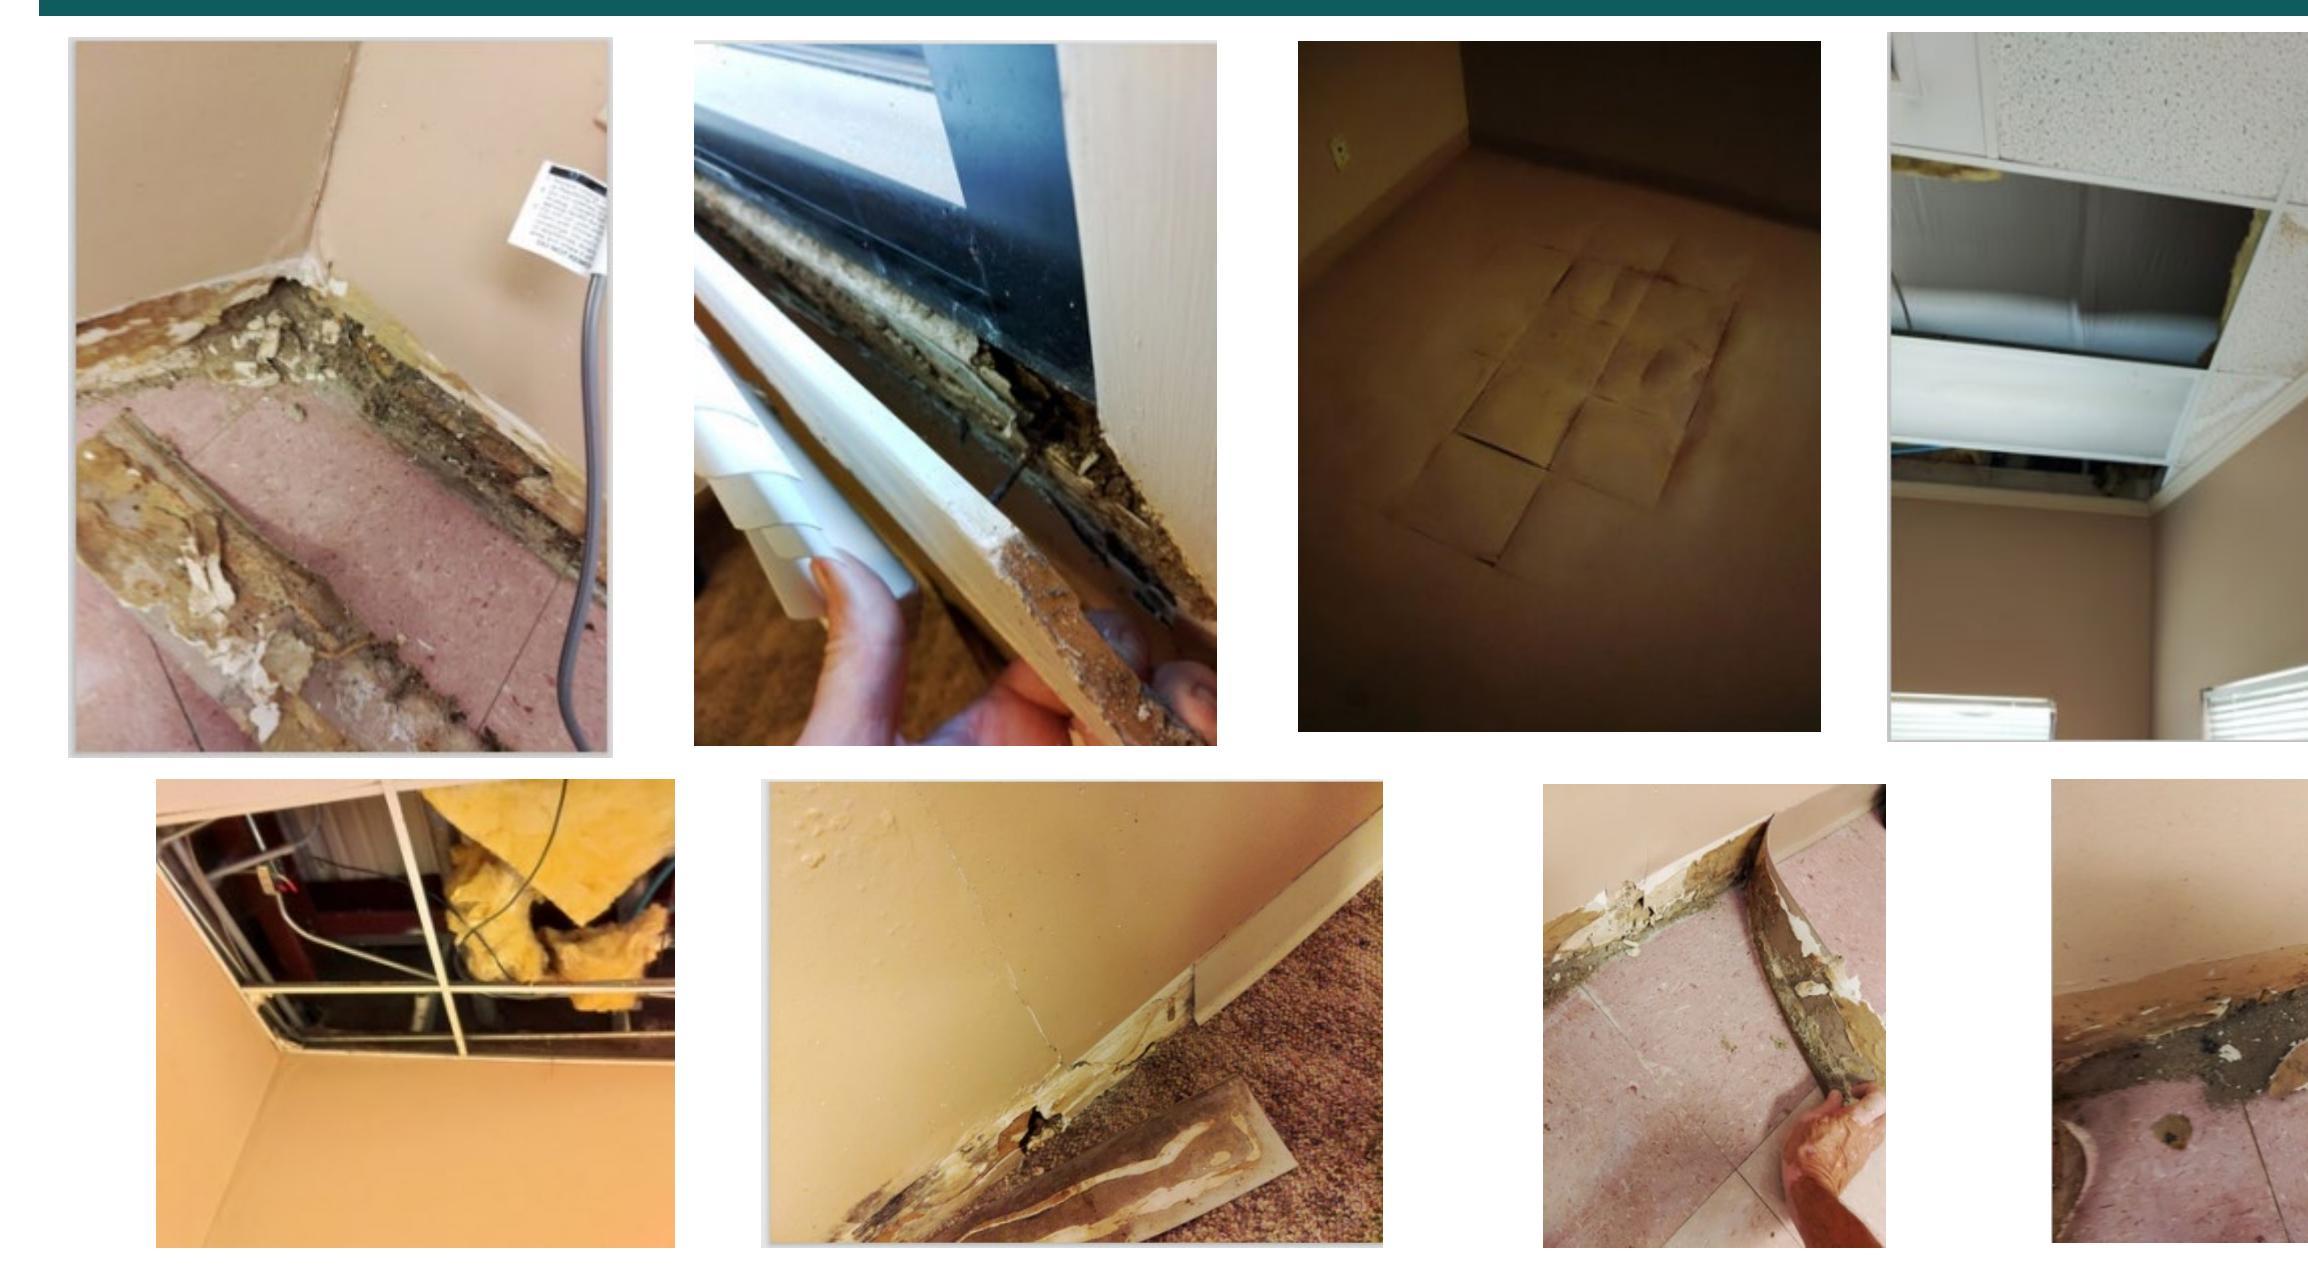
Images from Mold Report

- The results of the visual inspection revealed mold actively growing on areas of wall on rear of building where roof drains are located.
- There was substantial deterioration in the drywall up to 4 feet from the floor. Grade at rear of building needs to be corrected to remove excess soil from near building.
- Roof drain portals appear to be insufficient to allow proper runoff of rainwater causing water accumulation and leakage near rear of building.
- Multiple HVAC systems were inoperable.
- Poor environmental controls leading to excessive humidity that promotes mold growth

- Poor environmental controls.
- HVAC units need to be in full operational order.
- Roof leak issues need to be immediately addressed.
- Rear walls that have affected drywall should have demolition, cleaning and repairs performed.

- Based upon my observations, it is my opinion that the following mold remediation tasks would be warranted to eliminate and/or reduce the indoor fungal contamination.
- Remediation should be performed by a certified mold remediation contractor. The contractor should follow my guidelines as well as, in accordance with the IICRC S520 Standard and Reference Guide for Professional Mold Remediation.
- Repair HVAC units, clean and sanitize systems with an EPA registered anti-microbial agent and then turn off systems and seal until remediation procedures are complete.
- Repair roof and drainage.
- Repair rear walls and aggressively clean all areas where mold growth is present.
- Complete air wash of facility with an EPA registered disinfectant. Retest air quality before allowing building to be re-occupied.
